INDOOR AIR QUALITY ASSESSMENT

**K.C. Coombs Elementary School
152 Old Barnstable Road
Mashpee, Massachusetts 02649**

Prepared by:
Massachusetts Department of Public Health
Center for Environmental Health
Emergency Response/Indoor Air Quality Program
September 2005

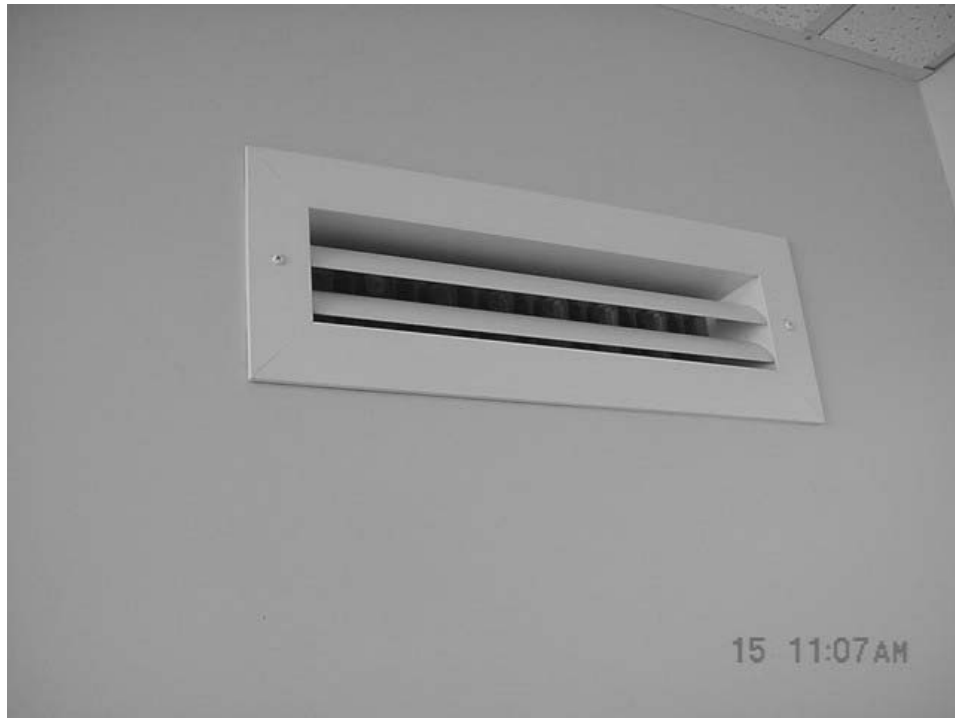
Picture 1

Mechanical ventilation in classrooms was originally provided by two wall-mounted vents located at the front of each classroom (Picture 1). One of the vents served as a supply vent that was ducted to an air handling unit (AHU) on the roof. The second vent served as a passive exhaust, which operates on the premise of pressurization. As air enters the room through the mechanical supply vent, the room becomes pressurized, which forces air into the exhaust vent creating air exchange. Once air is forced into the exhaust vent, it enters the attic which serves as an open plenum that is naturally vented with louvered gable vents (Picture 3). The mechanical ventilation system was upgraded in the mid 1990s,

Wall-Supply Vent for Original System

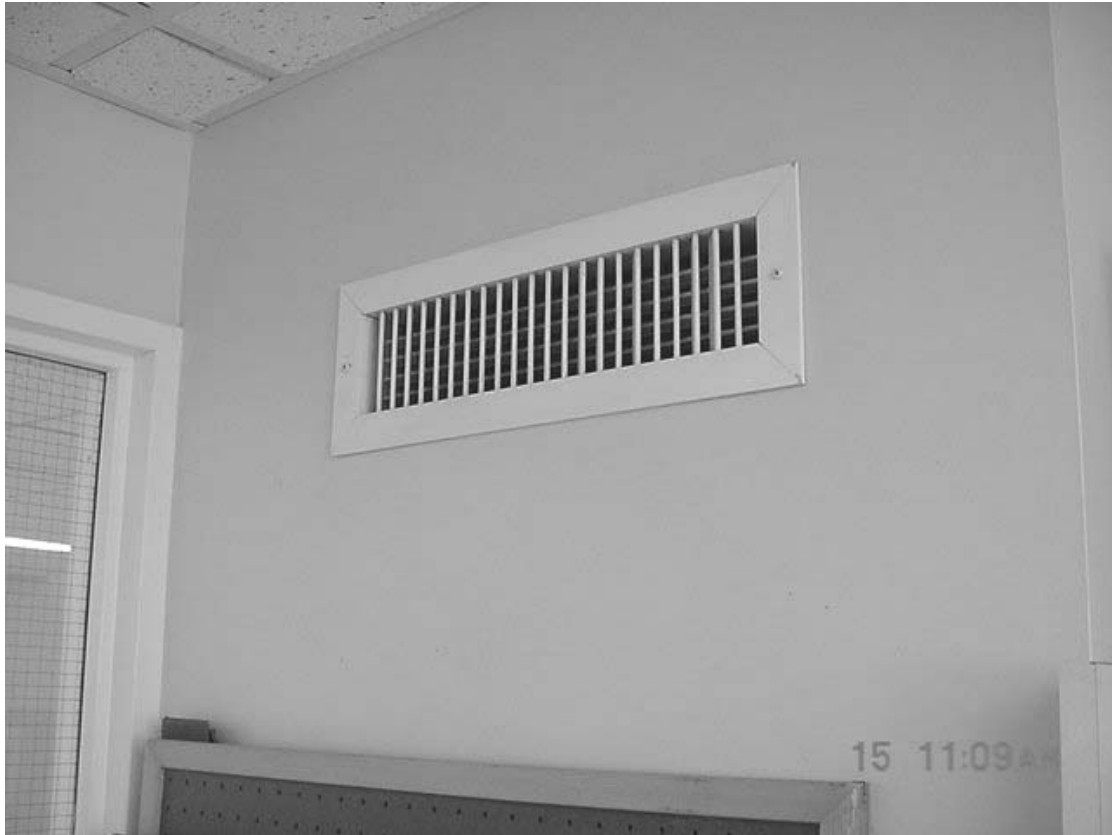
Picture 2

Passive Exhaust Vent

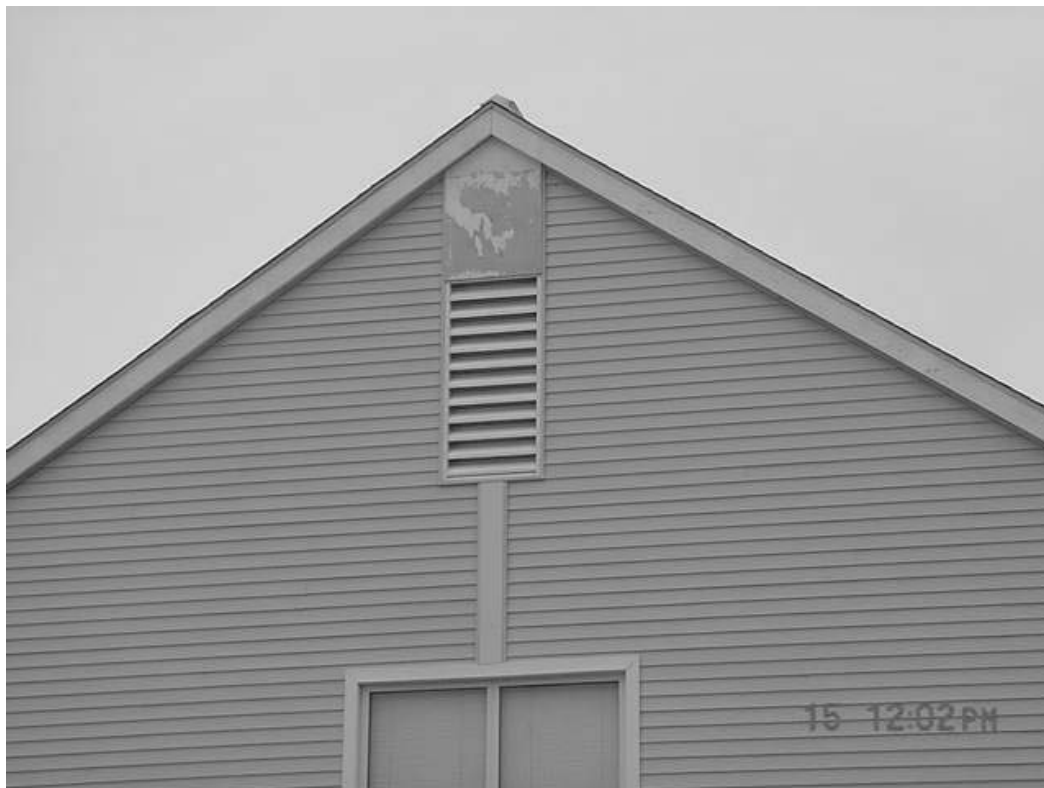
Picture 3

Louvered Gable Vent

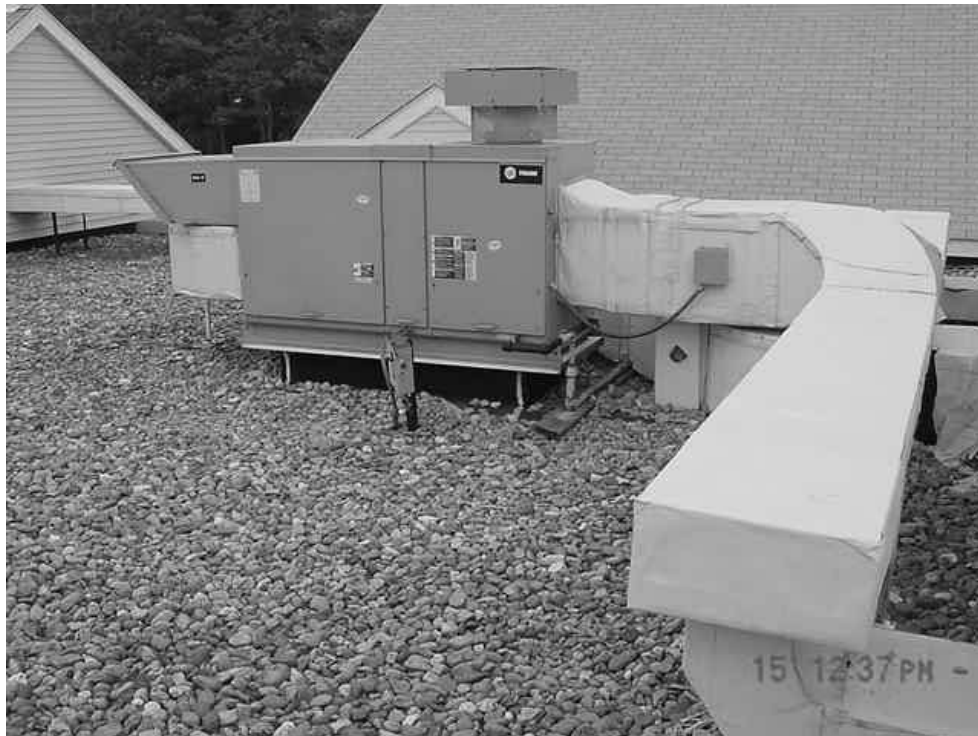
Picture 4

which added a number of additional AHUs on the roof (Picture 4) that are ducted to ceiling-mounted supply vents (Picture 5) as well as the original wall-mounted supply vent from the existing system. However, the exhaust system remains unchanged.

Ducted Rooftop AHU

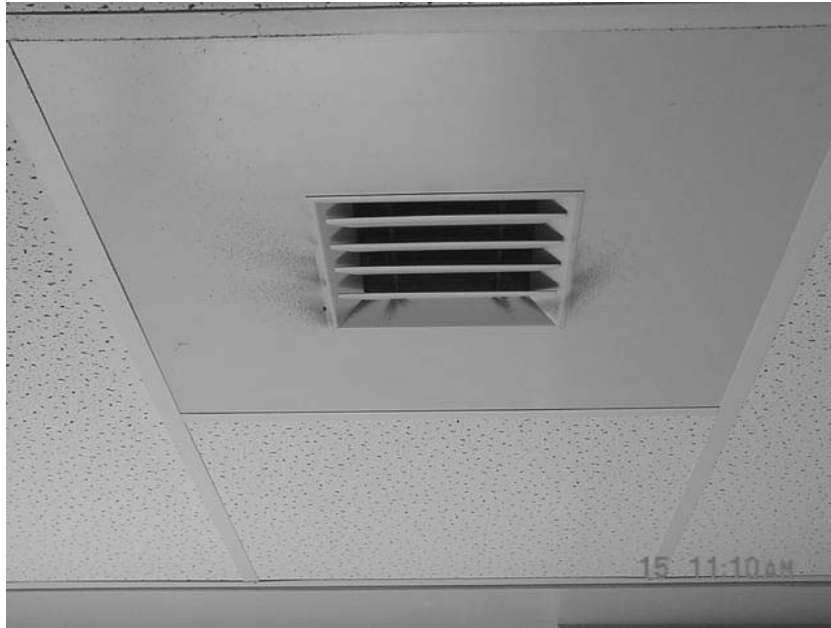
Picture 5

Ceiling-Mounted Supply Vent

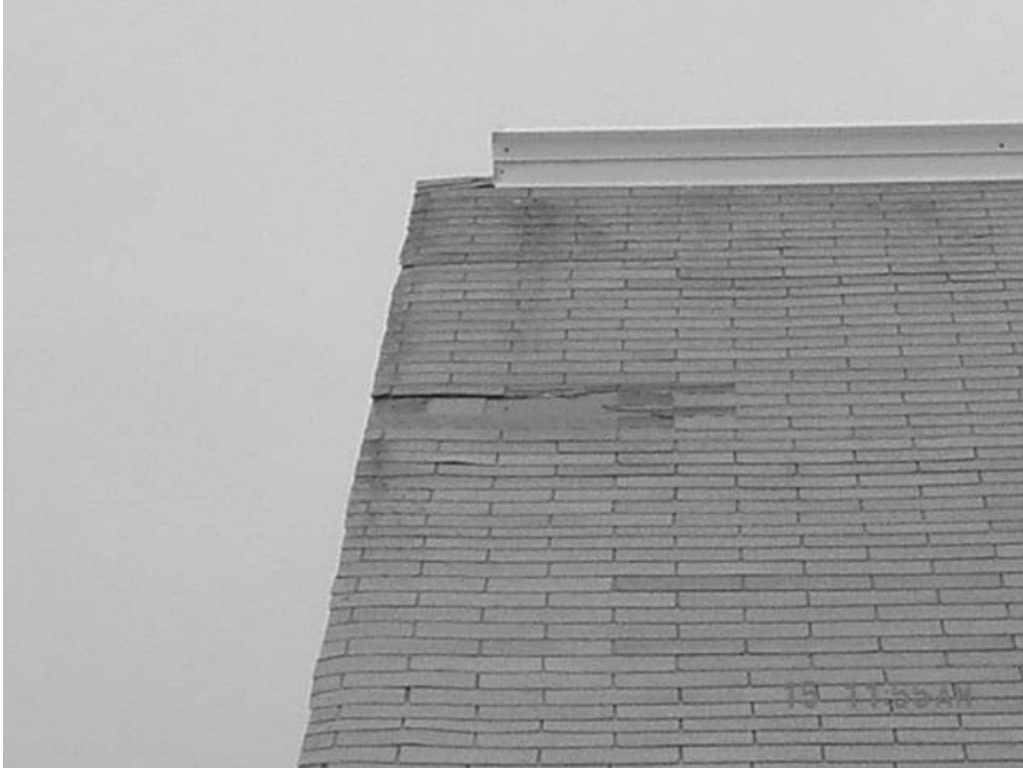
Picture 7

Missing/damaged roof shingles were observed in several areas (Picture 7). Mr. Tripp reported that these areas had become damaged during the winter storms of 2004-2005 and that MPS maintenance staff were in the process of making repairs, which was evident by rigging/scaffolding on the building exterior (Picture 8).

Missing/Damaged Shingles

6. Continue to make roof repairs to prevent potential water penetration.
7. Ensure all plants are equipped with drip pans. Examine drip pans periodically for mold growth and disinfect with an appropriate antimicrobial where necessary.

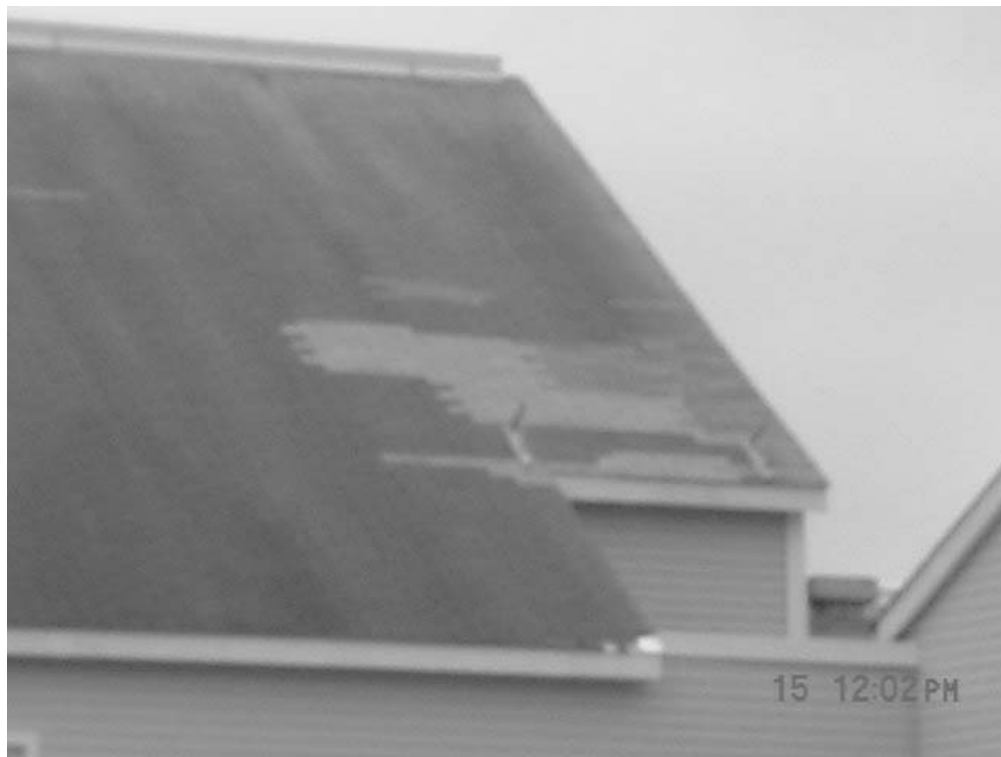
Picture 8

Section of Roof under Repair

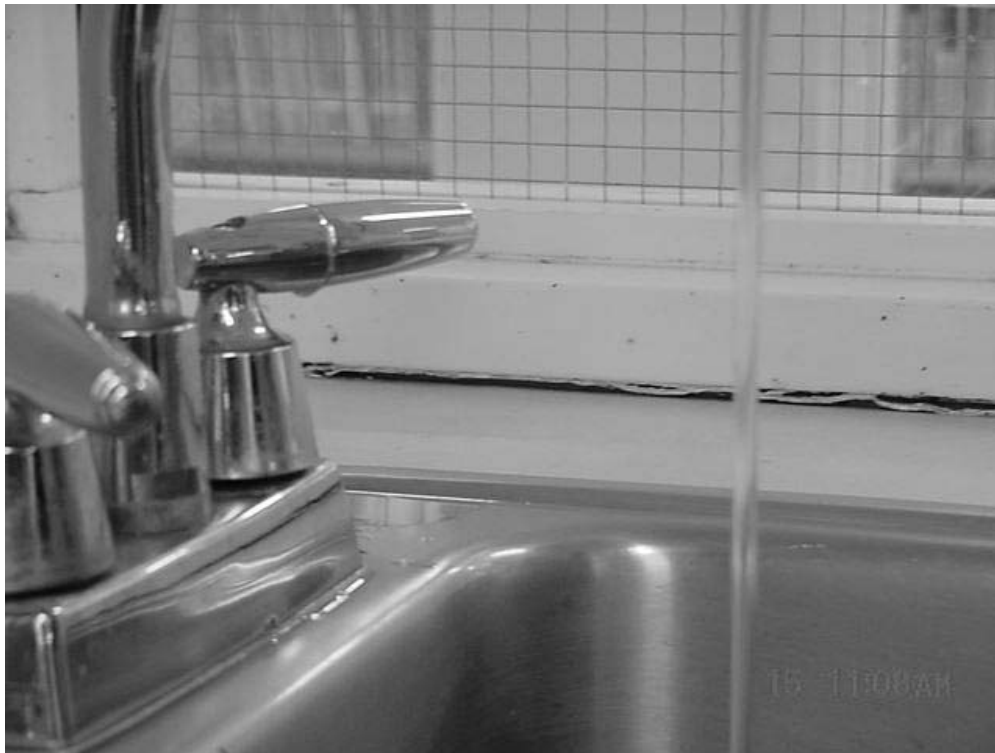
Picture 9

Open seams between the sink countertop and wall were observed in several rooms (Picture 9). If not watertight, water can penetrate through the seam, causing water damage. Improper drainage or sink overflow can lead to water penetration of countertop wood, the cabinet interior and behind cabinets. Like other porous materials, if these materials become wet repeatedly they can provide a medium for mold growth.

Space between Sink Countertop and Backsplash

8. Remove clinging plants from exterior walls.
9. Seal areas around sinks to prevent water-damage to the interior of cabinets and adjacent wallboard. Inspect adjacent areas for water-damage and mold growth, repair/replace as necessary. Disinfect areas of microbial growth with an appropriate antimicrobial as needed.

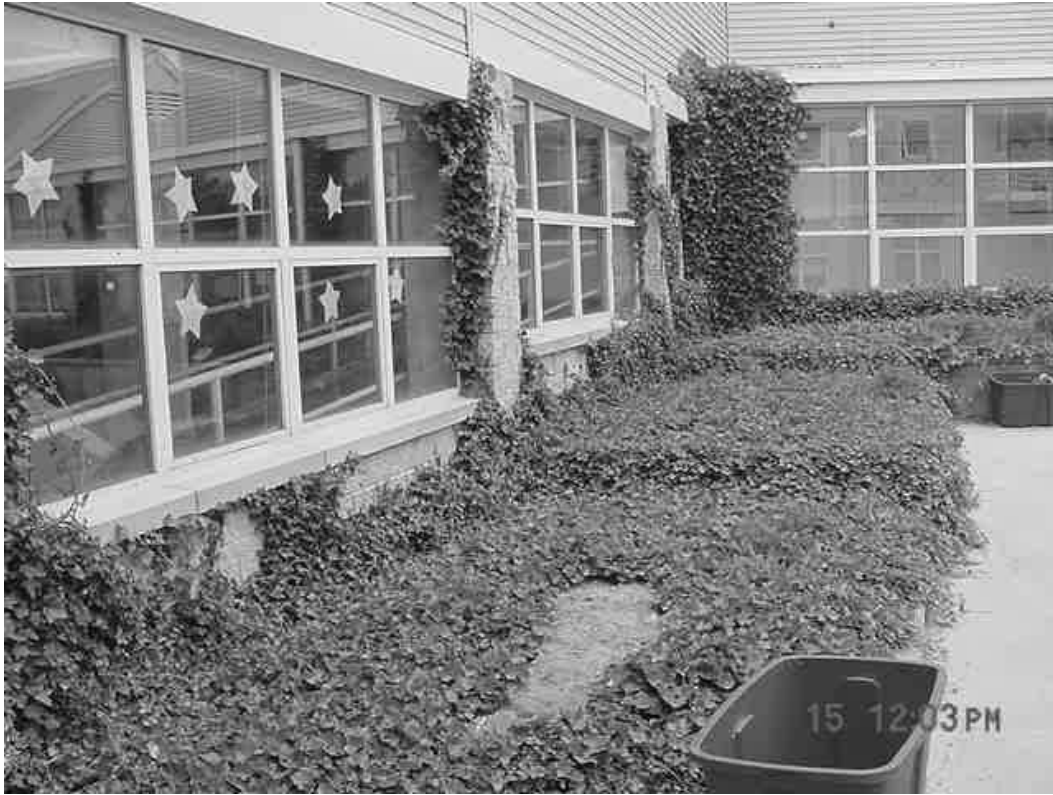
Picture 10

In several areas around the building, clinging plants were noted on exterior walls (Picture 10). The growth of plants/roots against the exterior walls and along the foundation can bring moisture in contact with wall brick and eventually lead to cracks and/or fissures in the foundation below ground level. Clinging plants can cause water damage to brickwork by inserting tendrils into brick and mortar. Water can penetrate into the brick along the tendrils, which can subsequently freeze and thaw during the winter. This freezing/thawing action can weaken bricks and mortar, resulting in wall damage.

Clinging Plants in Semi-enclosed Courtyard

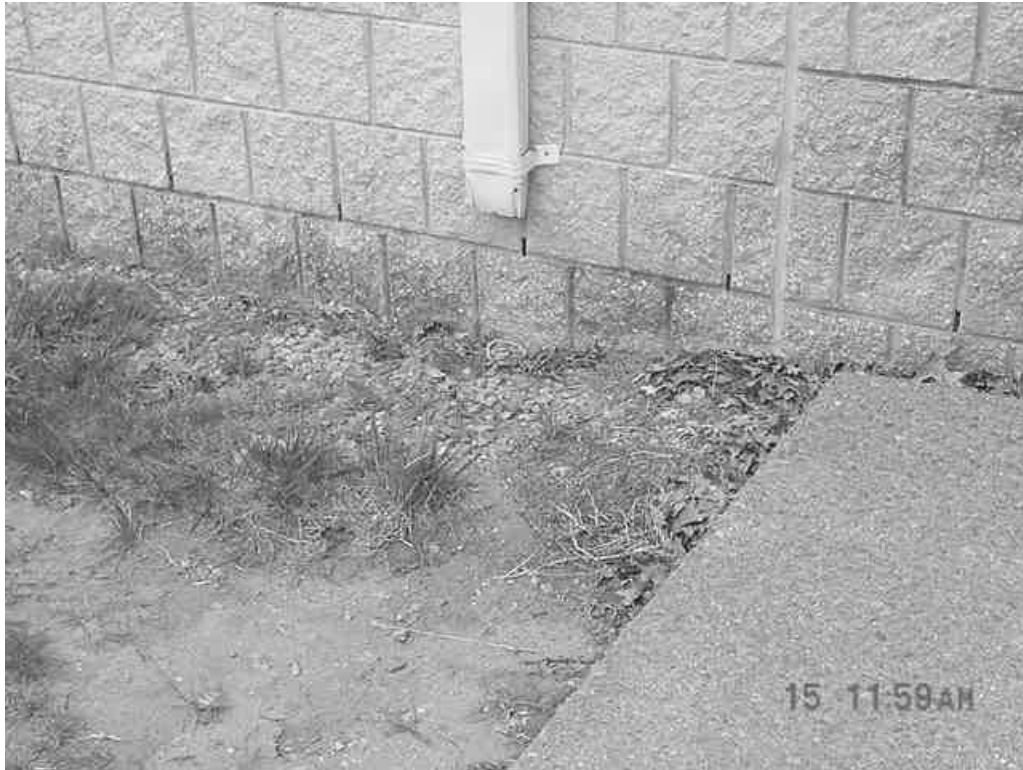
Picture 11

A gutter/downspout system provides drainage, however several of the downspouts were missing during the assessment (Picture 11), which can allow rainwater to pool on the ground at the base of the building or against exterior walls. The freezing and thawing action of water during winter months can create cracks and fissures in the foundation. Over time, this process can undermine the integrity of the building envelope and provide a

Missing Elbow on Downspout

10. Replace missing elbows to downspouts in a manner to direct rainwater away from the building.
11. Clean accumulated dust from blades of personal fans.

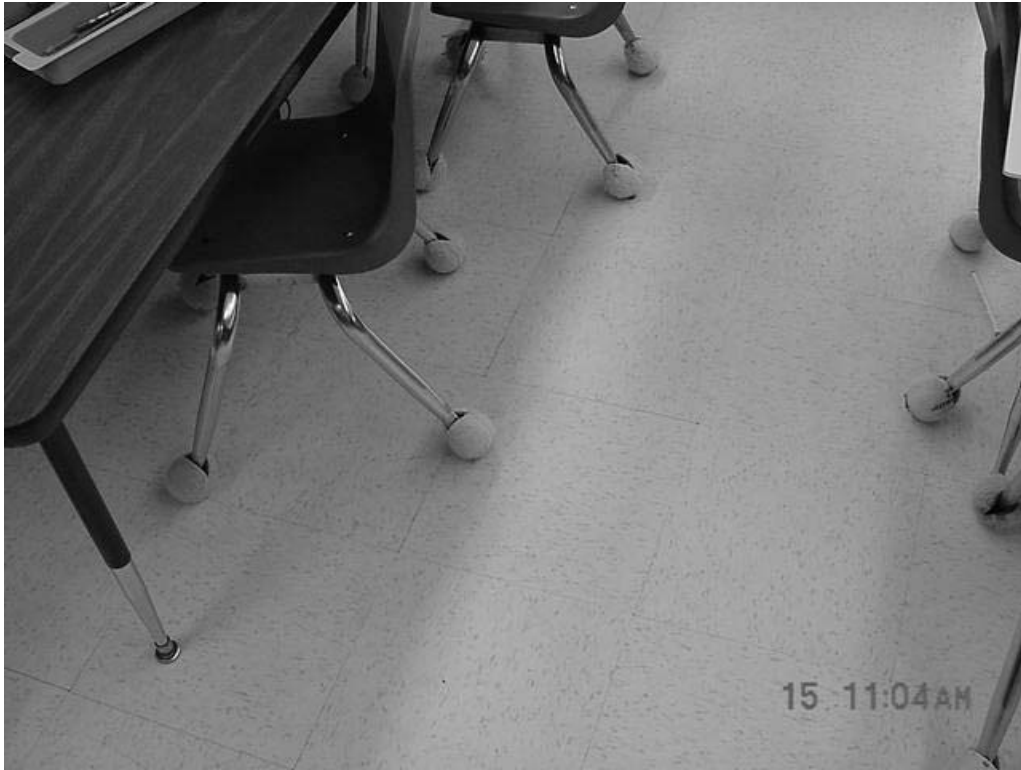
Picture 12

In an effort to reduce noise from sliding chairs, tennis balls had been sliced open and placed on chair legs (Picture 12). Tennis balls are made of a number of materials that are a source of respiratory irritants. Constant wearing of tennis balls can produce fibers and off-gas TVOCs. Tennis balls are made with a natural rubber latex bladder, which becomes abraded when used as a chair leg pad. Use of tennis balls in this manner may introduce latex dust into the school environment. Some individuals are highly allergic to latex (e.g., spina bifida patients) (SBAA, 2001). It is recommended that the use of materials containing latex be limited in buildings to reduce the likelihood of symptoms in sensitive individuals (NIOSH, 1997). A question and answer sheet concerning latex allergy is attached as Appendix B (NIOSH, 1998). Consideration should be given to replacing tennis balls with alternative glides (Picture 13).

Tennis Balls on Chair Legs

12. Consider discontinuing the use of tennis balls on furniture and replacing tennis balls with alternative “glides” (Picture 13).
13. In order to maintain a good indoor air quality environment on the building, consideration should be give to adopting the US EPA document, “Tools for Schools”, which can be downloaded from the Internet at <http://www.epa.gov/iaq/schools/index.html>.

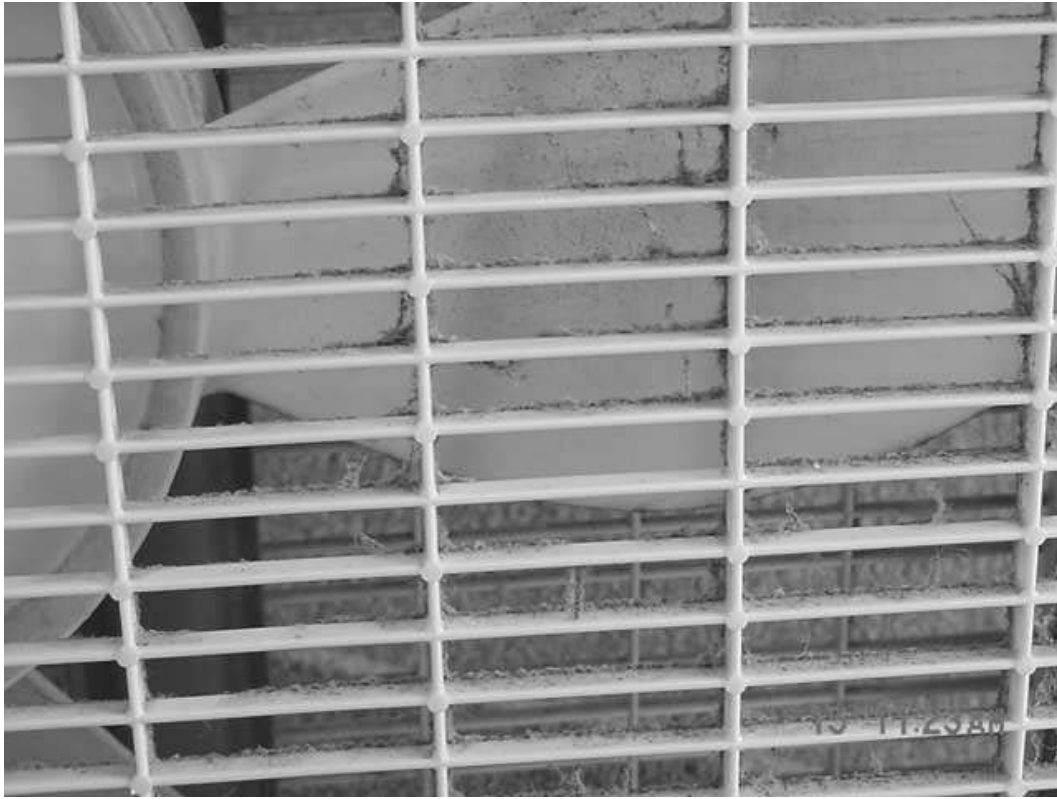
Picture 14

Dust Accumulation on Personal Fan in Classroom

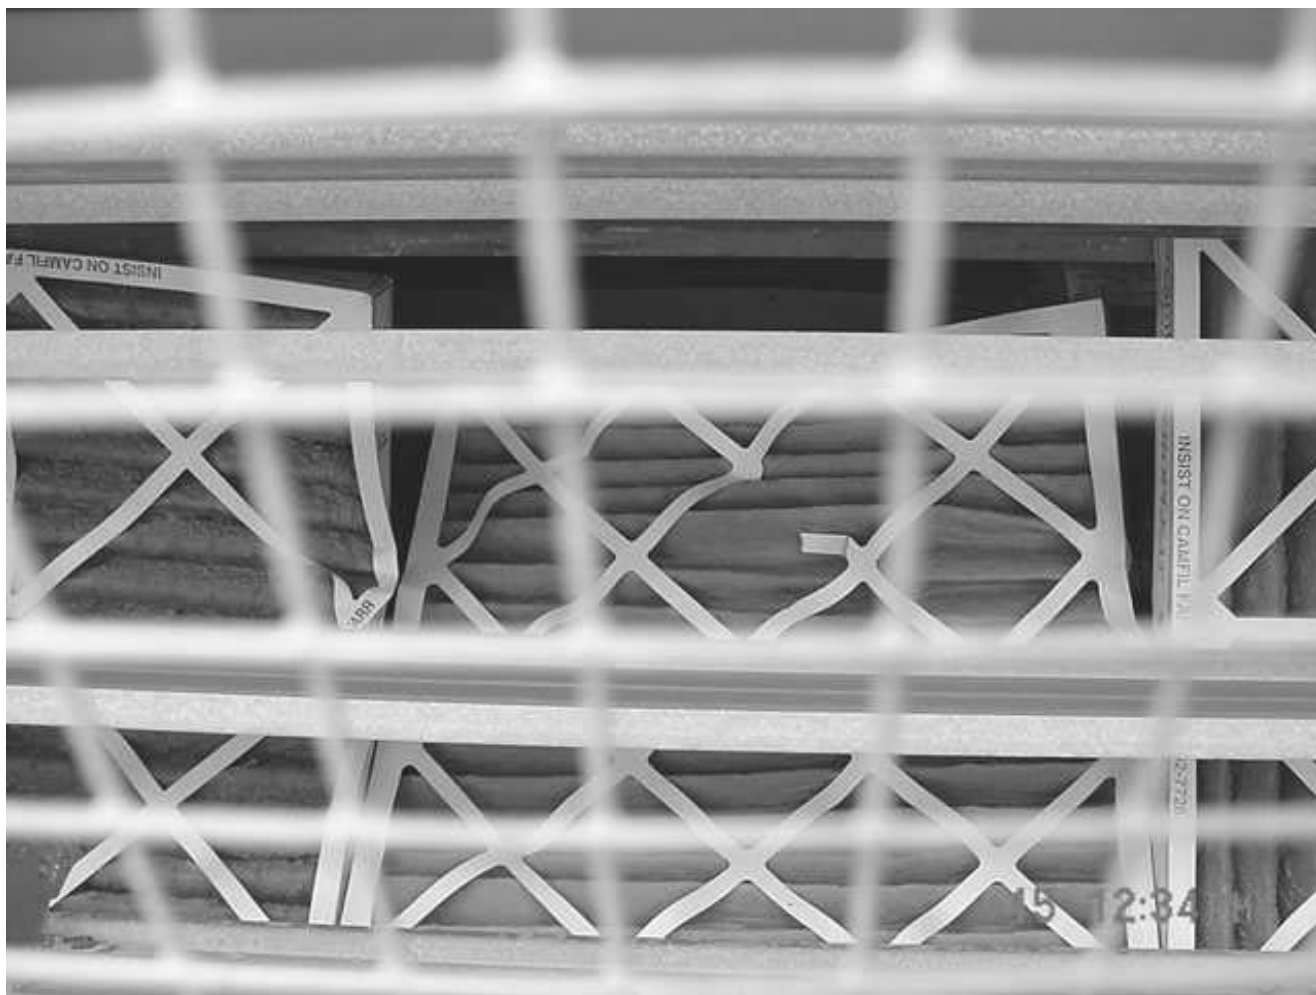
Picture 15

Lastly, AHUs are normally equipped with filters that strain particulates from airflow. The dust spot efficiency is the ability of a filter to remove particulates of a certain diameter from air passing through the filter. Filters that have been determined by ASHRAE to meet its standard for a dust spot efficiency of a minimum of 40 percent would be sufficient to reduce airborne particulates (Thornburg, 2000; MEHRC, 1997; ASHRAE, 1992). The filters installed in AHUs at the CES are high dust spot efficiency pleated air filters (reportedly changed four times a year). However, MDPH staff observed AHUs on the roof and found a number of the filters crushed/damaged (Picture 15). Mr. Tripp explained that this was an ongoing problem with cardboard-framed filters being “sucked-in” by the AHU intake fans. Without filters in place, spaces around filters can allow for unfiltered air to bypass the filters and be distributed by the AHUs. Mr. Tripp suggested a support framework could be made to prevent buckling of cardboard framed filters.

Crumpled/Damaged Filters in Rooftop AHU

1. Continue with current filter media and schedule. Contact an HVAC filter manufacture/vendor for advice on preventing filter damage or consider fabricating framework to support filters without impeding airflow. Ensure filters fit flush in their racks with no spaces to prevent bypass of unfiltered air.
